FORT MOULTRIE DRAINFIELD TEST EXCAVATIONS
(SEAC ACC 826)

TRENCHLINE EXCAVATION MONITORING (SEAC ACC 837)

FORT SUMTER AND FORT MOULTRIE NATIONAL MONUMENT

DAVID M. BREWER

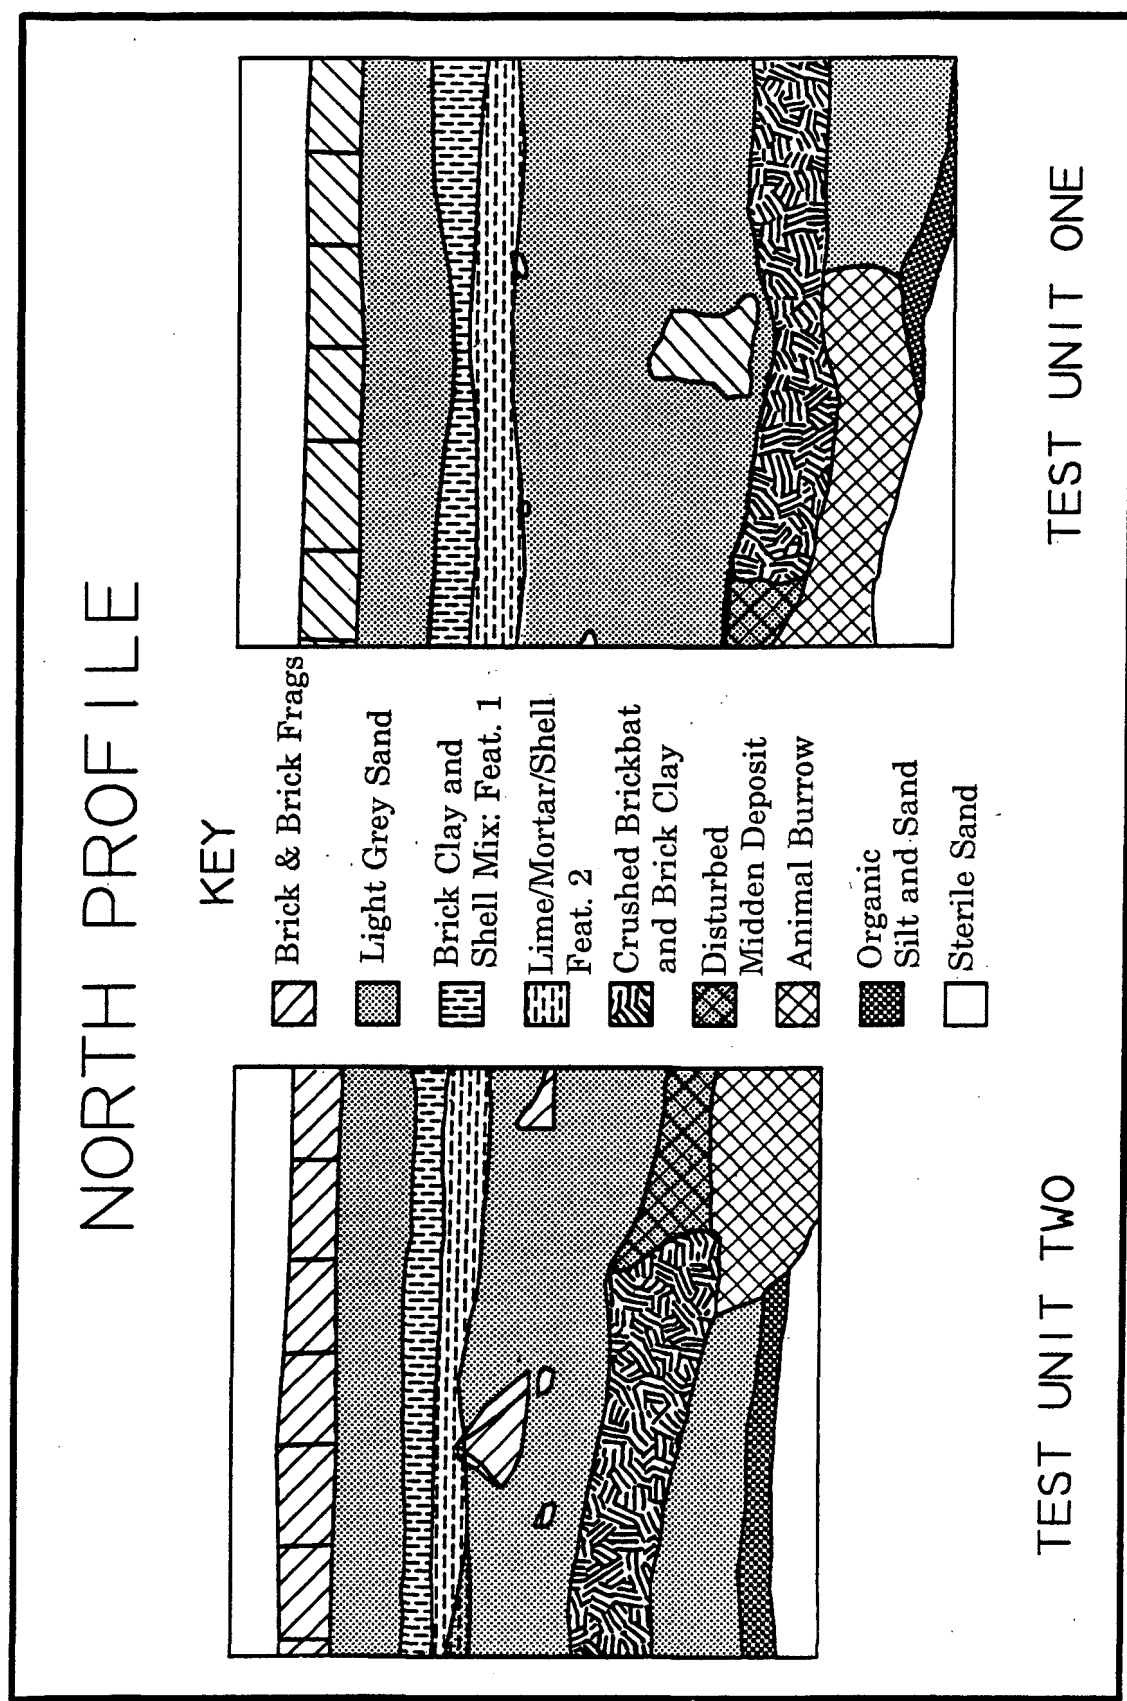
Figure 2. North Profile of Test Unit One and Test Unit Two

The unit was dug in observed strata, or natural zones, and all depth measures were taken from below ground surface (b.g.s), which was the level surface of the brick floor of the interior of the fort (See Figure 2).

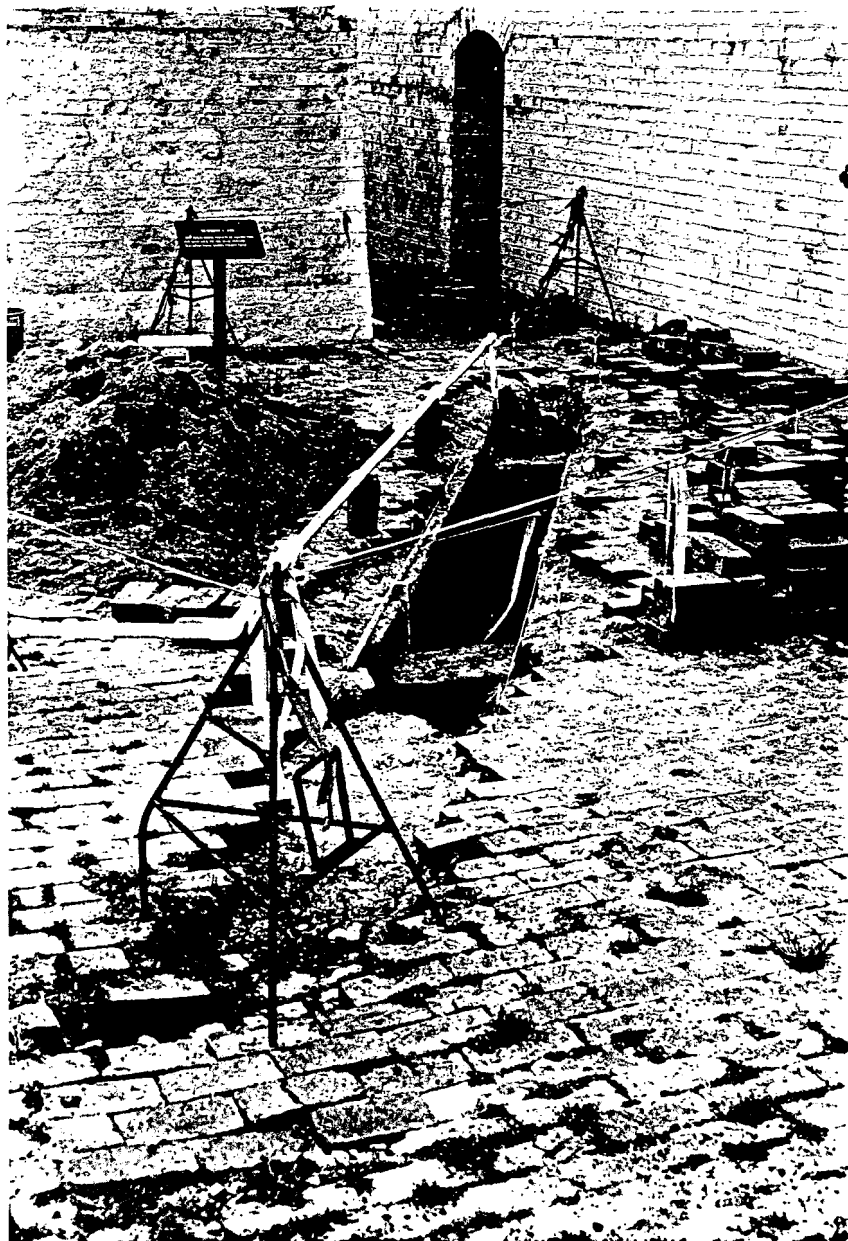
Photo 7. ACC 826, Test Unit, Trench 4. Wall "A" in foreground, Wall "B" in background. View Northwest.

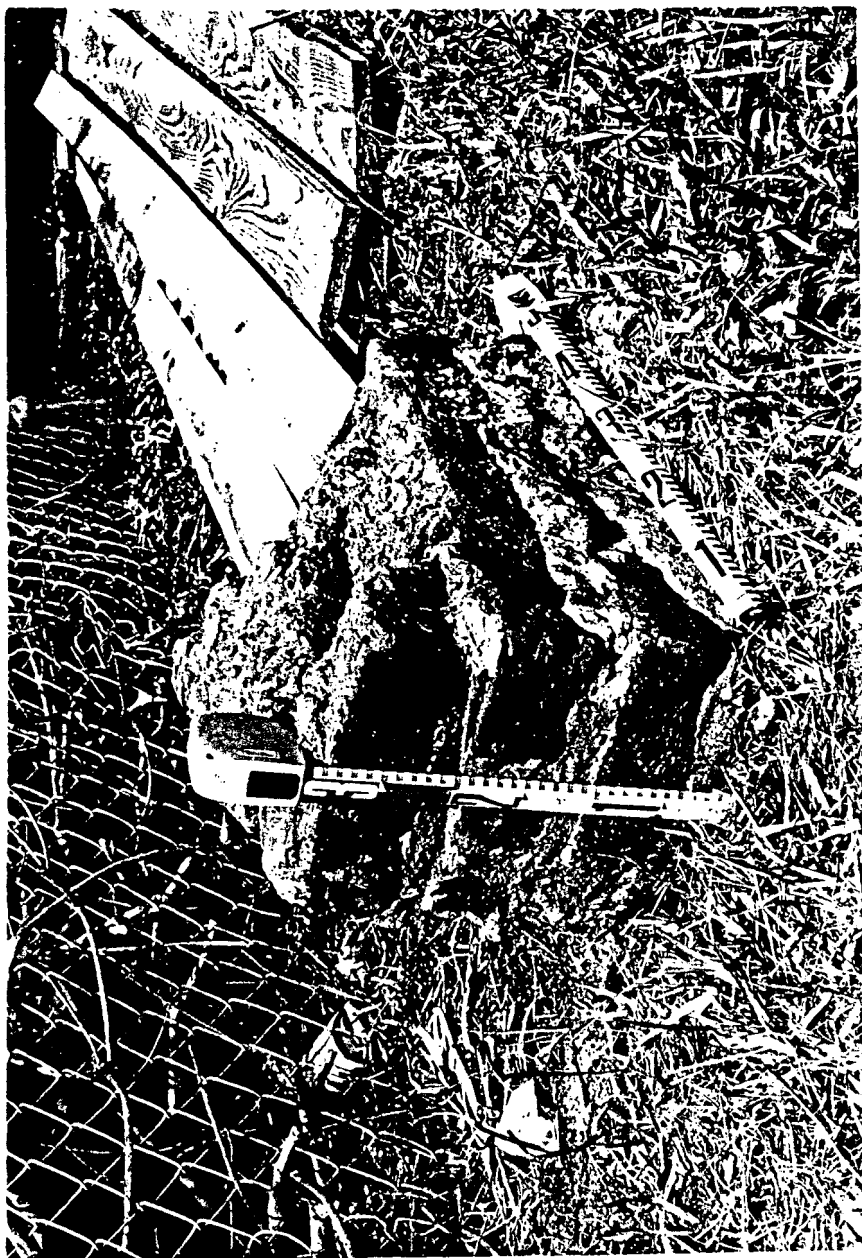
During this final removal of sand from the Postern floor, a large portion of a square brick pillar was encountered. At first it appeared to be architectural fabric and was designated as **Feature 1**, for this monitoring project. This was a partial square brick column, lying just below the Postern floor bricks. Avoidance of this feature was being discussed when, upon closer examination, it became apparent that this brick column feature was loose and simply resting in and on the sand fill below the brickwork. Therefore, it appeared to be a component of the fill and was removed (Photo 10).

Photo 10. Feature 1, Column Fragment. Removed from Postern floor fill.

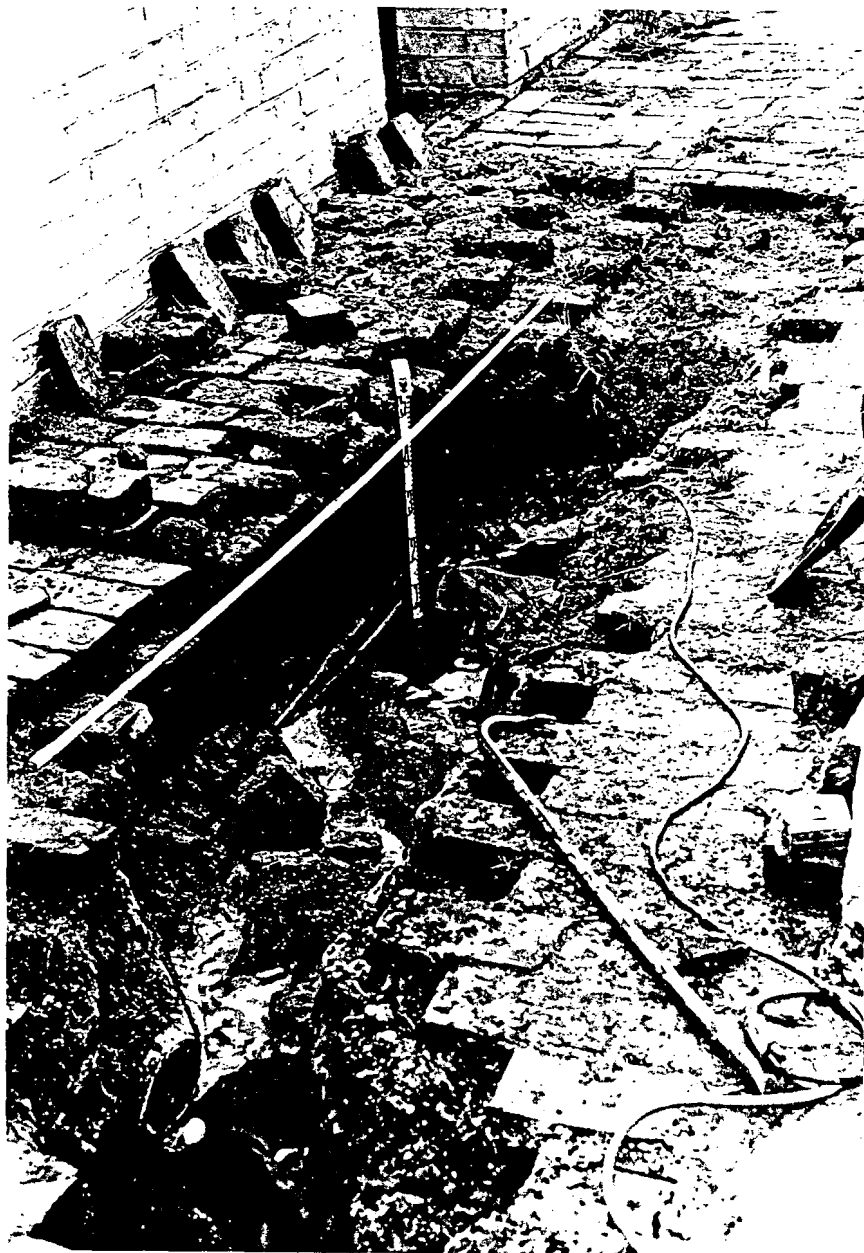
Photo 13. ACC 837, Trench 2 and 3, 1978 Sump Tank Exposed, View Northeast.

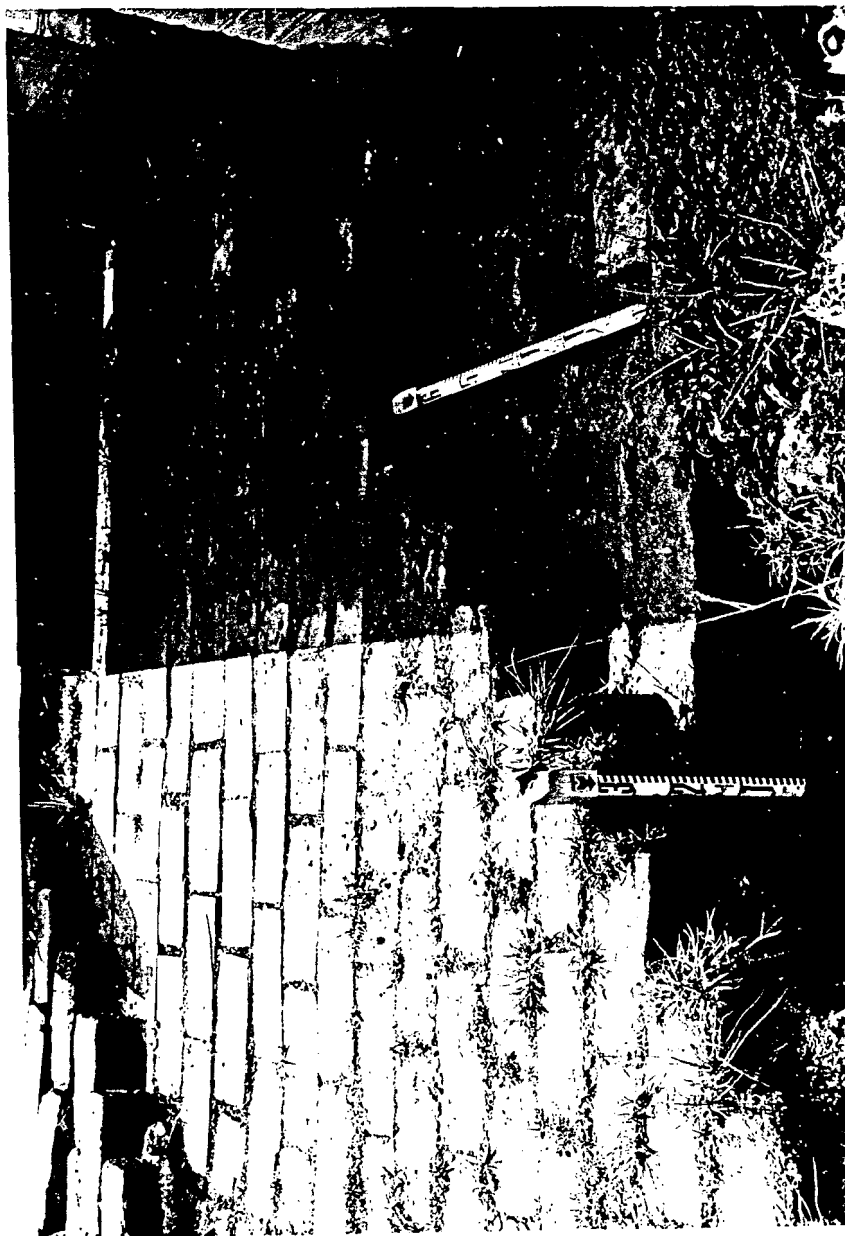
known to hold standing water. Once this trench had been started through the doorway however, a subsurface brick foundation, designated **Feature 7**, was encountered immediately adjacent to and running north from the westernmost Magazine gallery doorpost (Photo 15). This brick foundation was a massive solid brick subsurface structural component 5 courses wide (60 cm) and over 7 courses deep (75 cm +), starting from one course below surface. The subsurface wall foundation ran directly north to the Storage Magazine door, and it was assumed that a parallel wall foundation ran from the east Magazine courtyard doorjamb as well.

Photo 15. ACC 837, Feature 7, View East.

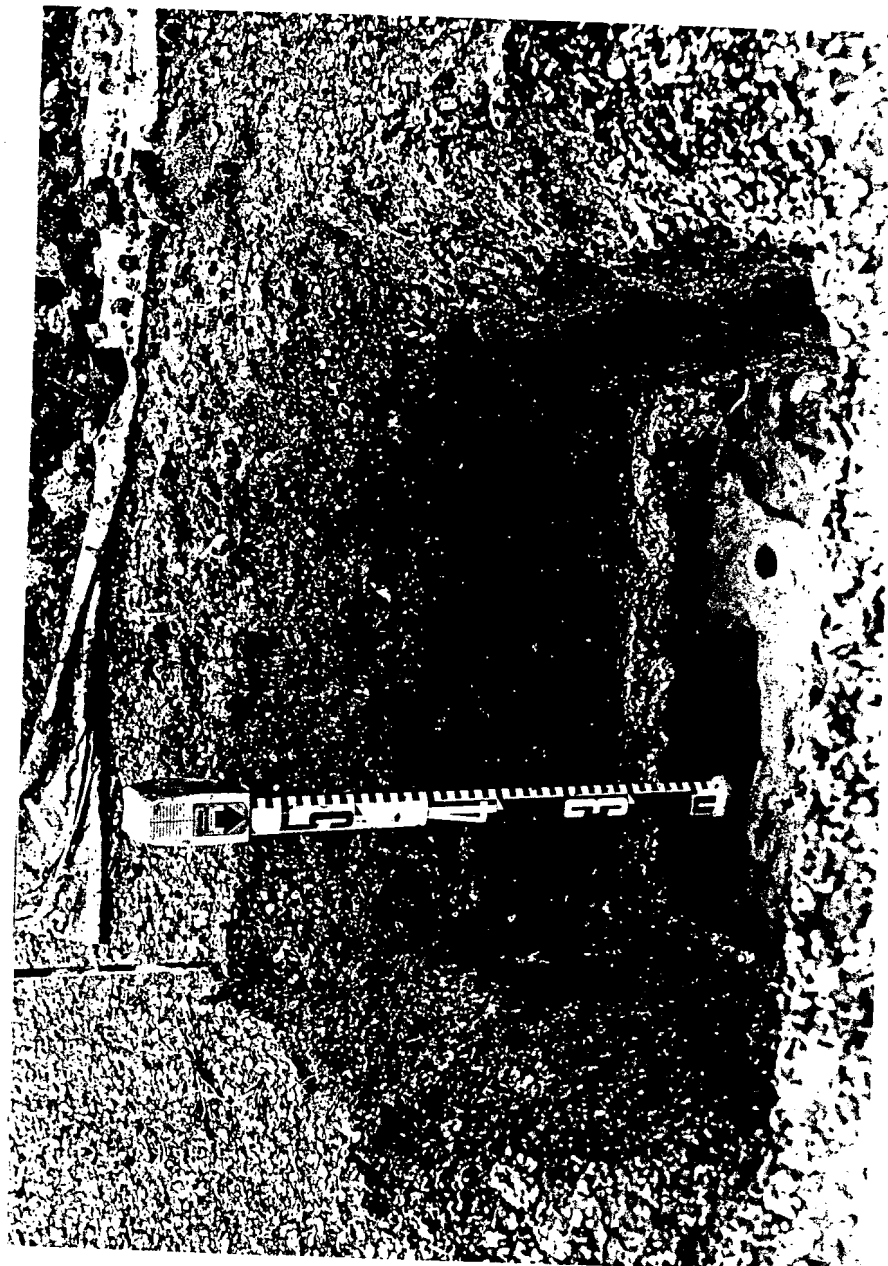
By far the greatest concentration of materials were observed from **Shovel Test # 14** (the last test dug), the center of which was at 8.75 m, 245 degrees magnetic, from the flagpole west of the Sally Port. Provenience appeared mixed however, and the slope of the ground indicated that this was the foot of the Sally Port protective berm, known to have been created with fill from an unknown source. Materials from all the shovel tests were noted only and not recovered. Other than the corner of a concrete slab in **Shovel Test # 5** which was the buried remains of a concrete and brick post footer just off the West Barracks south piazza corner, partially exposed at the surface, no structural remains were encountered. No remains of the hot-shot furnace, historically known to have been in the south side of the parade ground, were encountered or observed.

Photo 19. ACC 837, Shovel Test #14, Profile, View West. Note Old Parade Level.
